April 19, 2016

RE: Dataw Drive Entry Road Bridge Inspection-2016
JMT Job No. 13-0492-003

JOHNSON, MIRMIRAN & THOMPSON, INC.

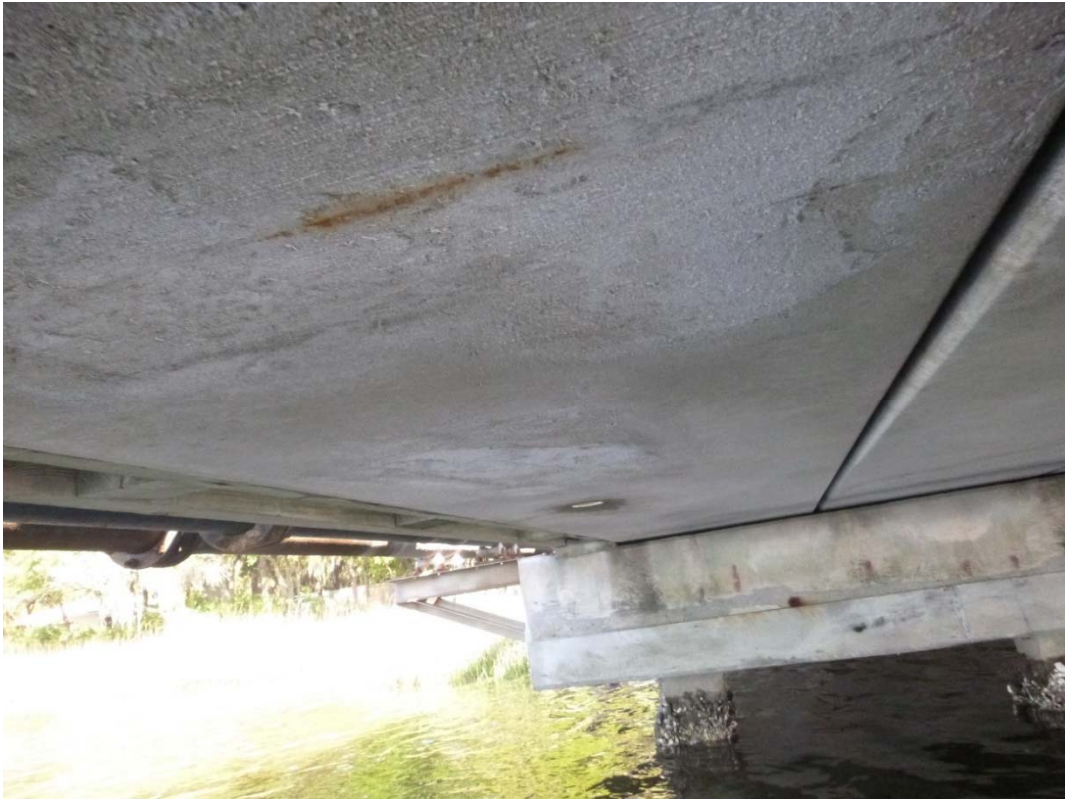
The areas of concern noted by Dataw personnel were reviewed. In several areas, including a few of the previously repaired areas showed signs of leaching rust stains. These areas were limited to the stirrups that run perpendicular to the bridge span. The stirrups are used in production to support the strands during casting and provide the shear capacity required by design. The leaching rust on the bottom portion of the stirrup does not create a structural concern for the bridge. It was noted on the field notes and will be inspected annually for accelerated decay. The intent is to watch until such time as it is warranted to conduct another repair contract, or until the cost benefit suggests replacing the bridge.

Leaching rust stains from bottom of stirrups bars

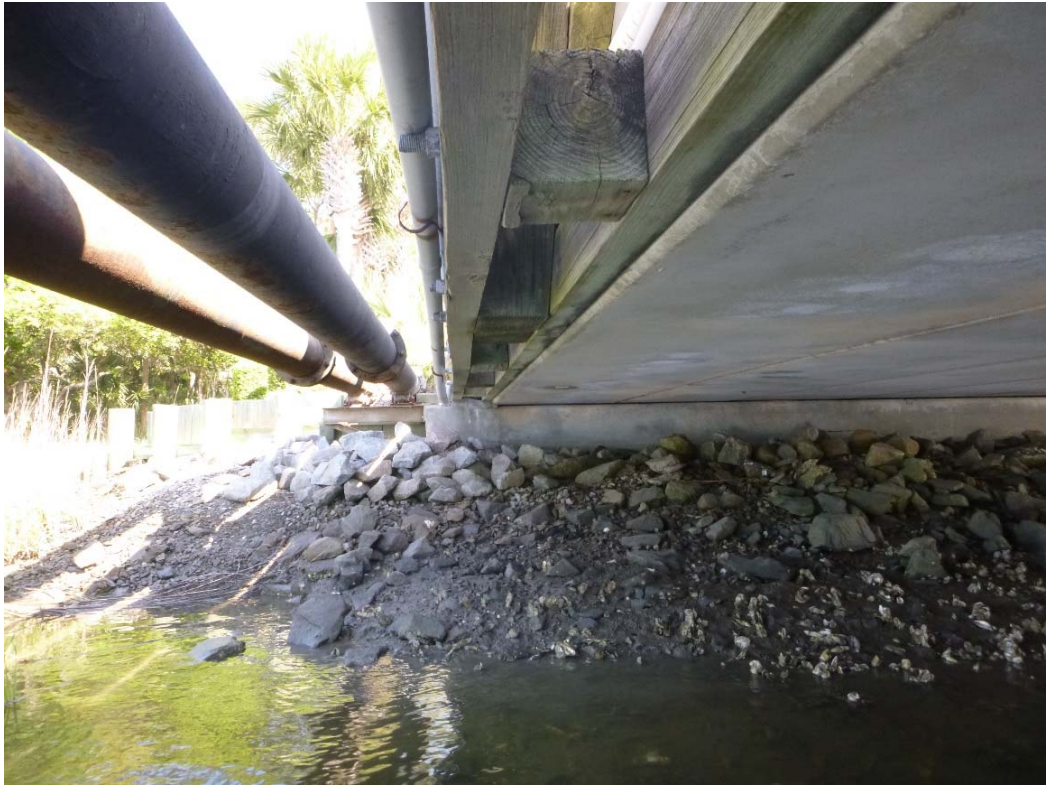
During the inspection on April 19th, it was observed that the piles, while mostly encased by marine growth, the pile-cap interaction zone was still exposed and appeared to be in good condition, free of spalls and cracks. The repaired areas of the pile caps appeared to be in good condition. The concrete patches were tested by sounding with hammer strikes, listening for dull hollow sounds and observing any cracks or flaking under the blows. The special repair to the problem box beam was also subjected to hammer strikes and the repair appears to be satisfactory.

Visible panel repairs

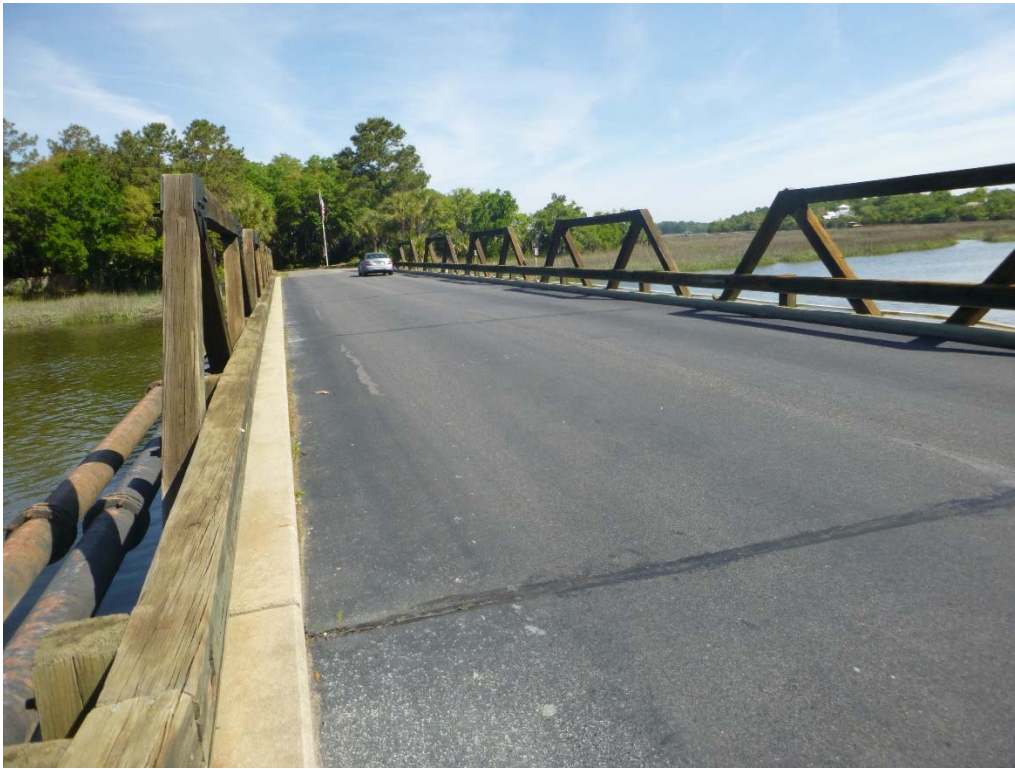
Riding surface

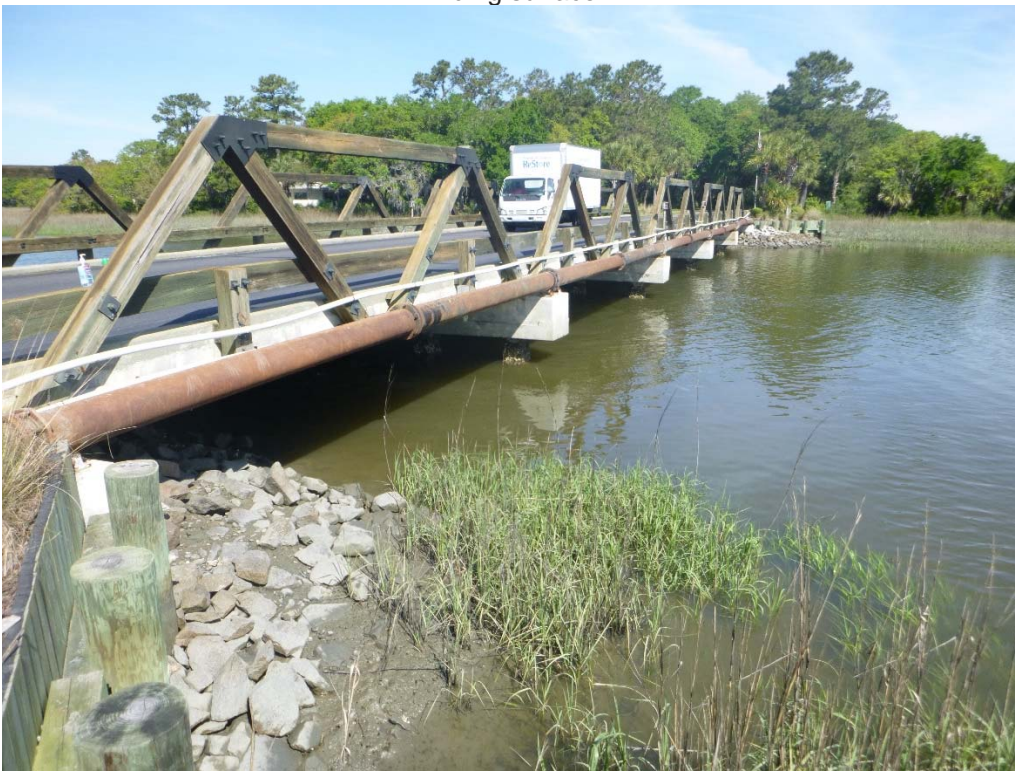
Bridge profile/Cap repairs

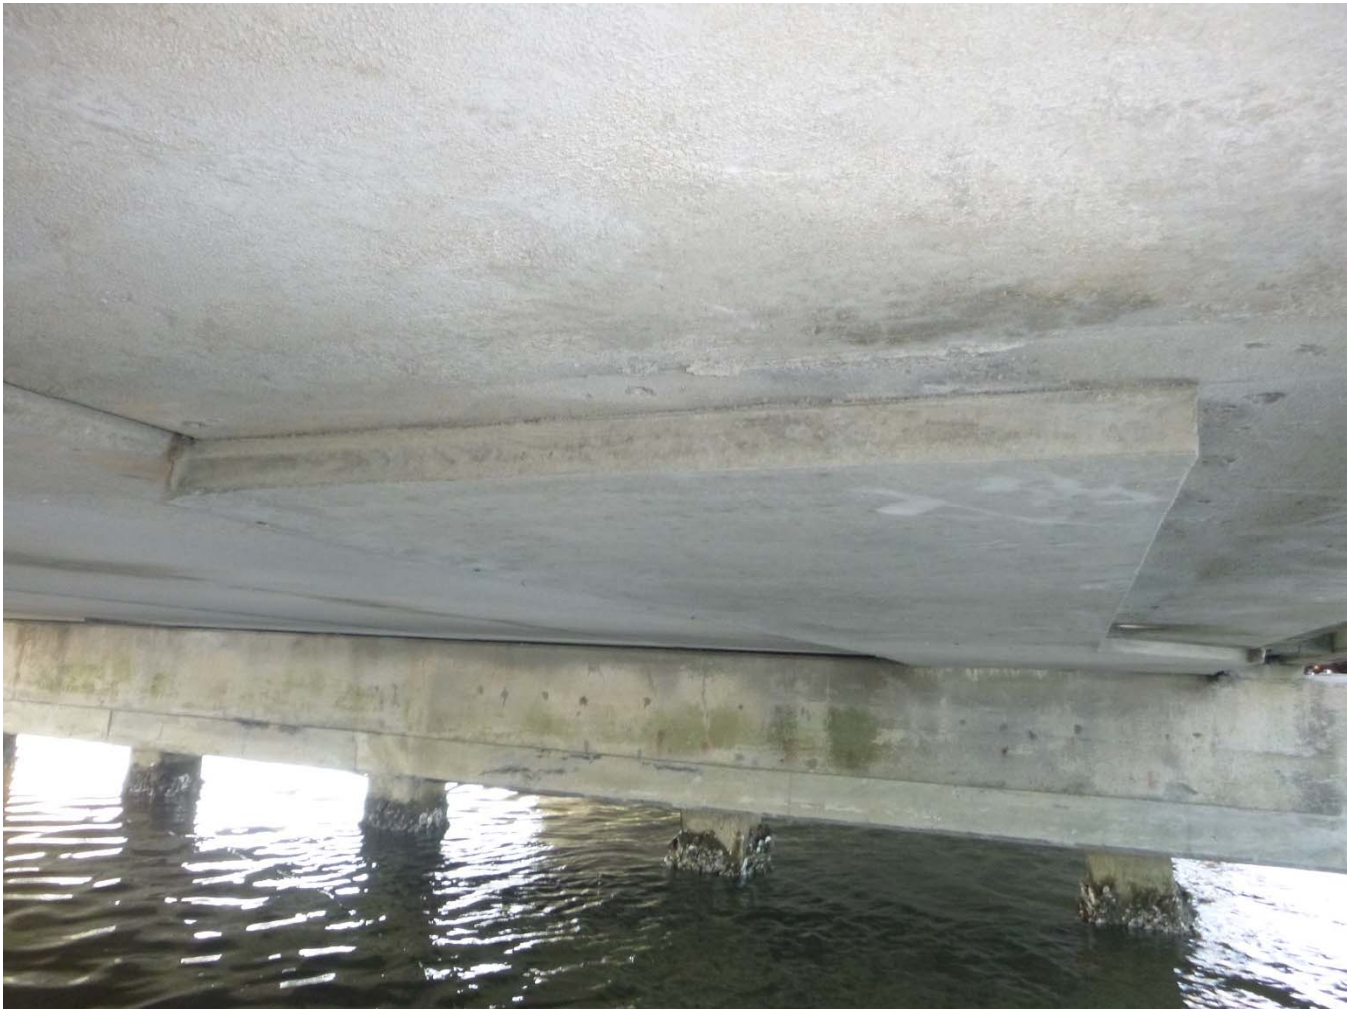
During the demolition phase of the repair work, one panel in particular was discovered to have extensive corrosion at the pre-stressing strands. A large spalled area of concrete was removed and several broken strands were exposed. JMT analyzed the box beam, based on the original design drawings, and determined that the box beams appeared to have been cast with a sufficient number of strands to accept to loss of those strands without requiring a reduction in axle loading. A special patch was applied in this area with the intent to extend the life of that panel to match the others.

Special panel repair location

This discovery of deterioration prompted a brainstorming session to determine the options for future repairs, including replacing single panels or adding additional structure to shore the panels as they decline. Through coordination with the contractor while developing costs, it was determined that replacing a single panel is a costly undertaking. It requires deconstruction of portions of the deck and traffic control during the replacement process. Other options include shoring the panels with a steel beam or using an FRP fiber wrap product to replace the tensile capacity of the bottom flange of the box.
