JMT Special Dataw Island access bridge inspection summary. 9/25/23

SPECIAL INSPECTION NOTES ON 2022 REPAIR ITEMS

PROJECT TITLE:
Special Inspection
9-19-2023

LOCATION AND DESCRIPTION OF DEFECTS w/PICTURES

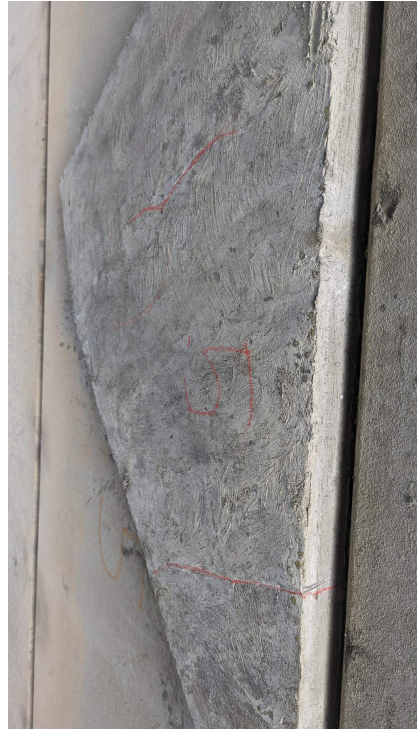
DEFECT 5: 2-18" Long Transverse Hairline Cracks

At this stage, JMT recommends just monitoring the cracks over the next year or so. You are scheduled for a regular biennial (2 year) inspection in January, and another special inspection before Ngeineering's 2 year warranty period is up. Now that we have a baseline, we recommend just keeping an eye on things to make sure the cracks are not opening to either greater thicknesses or quantities over time. If this turns out to be the case, JMT would recommend Ngeineering at the minimum seal the cracks with an appropriate compound to eliminate the pathway for salt penetration. Depending on the degree of advancement of the cracking (if any), repair item replacement could be necessary and that would be evaluated before the end of the warranty period.

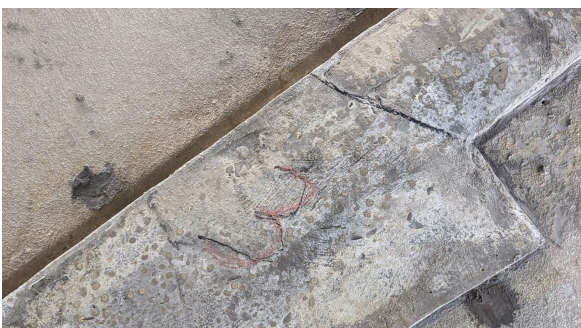
DEFECT 3: 1-8" Long Hairline Crack

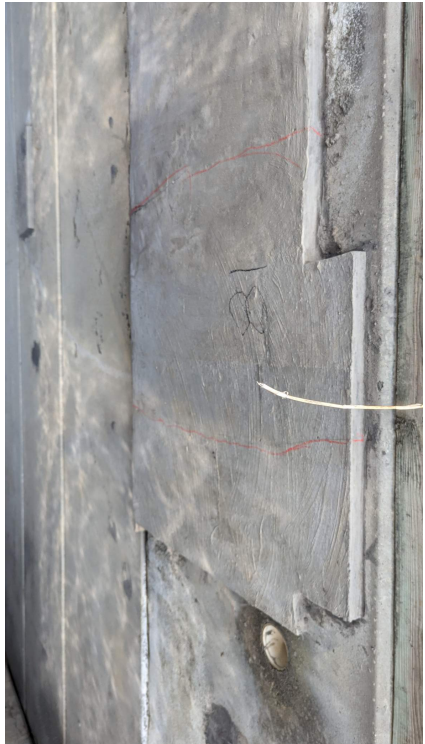
DEFECT 18: 2-Full Width Transverse Hairline to 1/32" Cracks

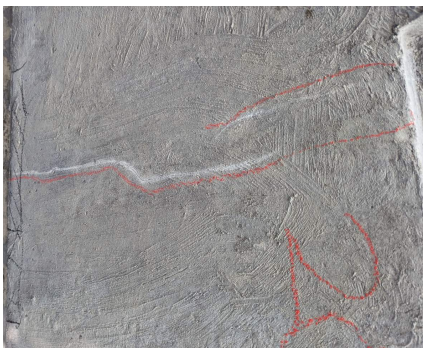
DEFECT 20: 1-9" Long, 1 Full Width Transverse Hairline Crack w/Efflo, 12"x3" Delamination at East Face of Patch

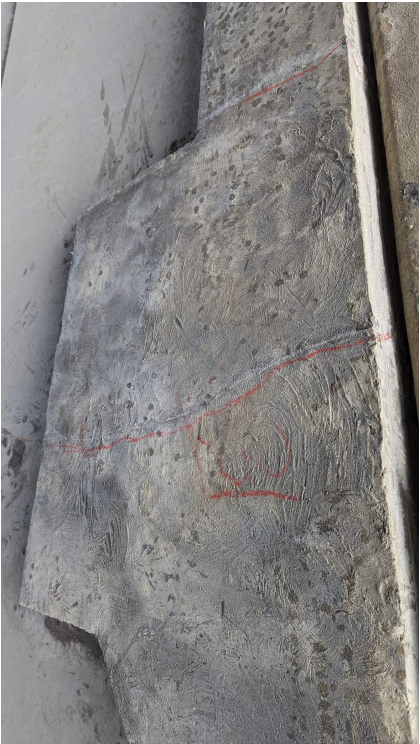
DEFECT 31: 2-Full Width Transverse Hairline w/Efflo.

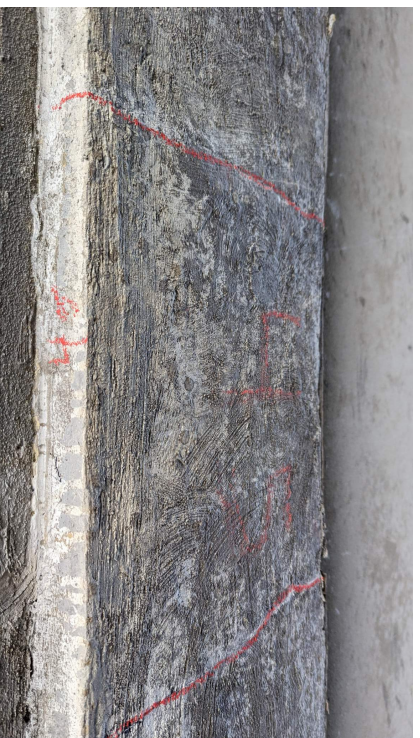
DEFECT 45: 2-Full Width Transverse Hairline w/Efflo.
